NASA Technical Paper 1699

AUGUST 1980

# Crash Tests of Four Identical High-Wing Single-Engine Airplanes

Victor L. Vaughan, Jr., and Robert J. Hayduk  
*Langley Research Center*  
*Hampton, Virginia*

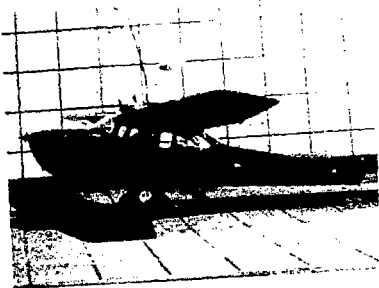
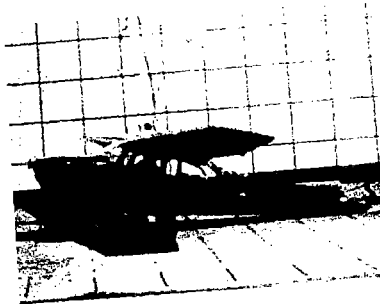
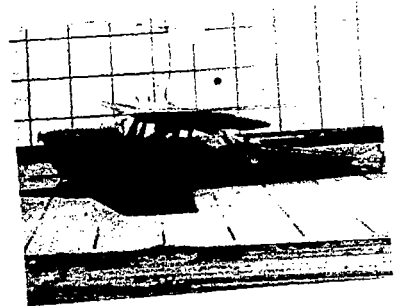
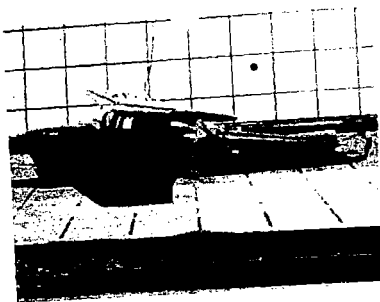
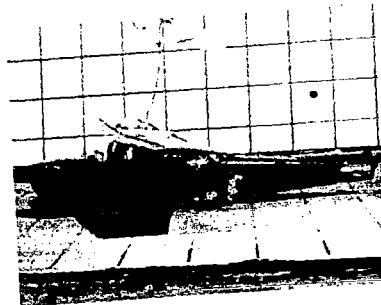
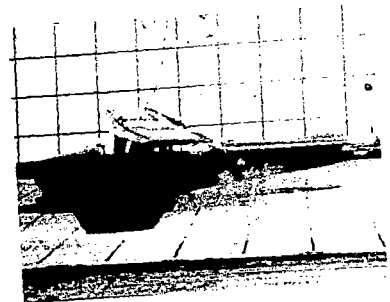
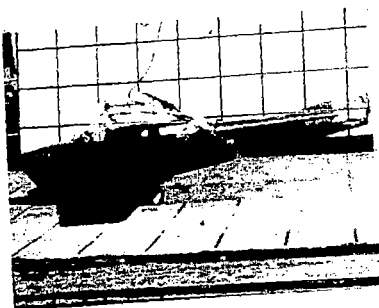
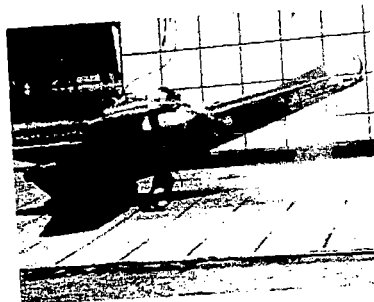
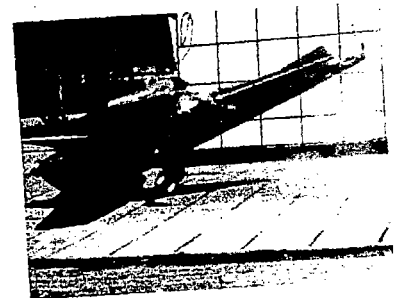
Figure 14.- Crash sequence photographs of hard-landing test. L-77-2206

A photographic sequence (fig. 14) illustrates the crash dynamics of the airplane test specimen during a simulated hard landing starting at initial ground contact. The airplane specimen contacted the concrete impact surface on the starboard landing gear with a velocity of 22.7 m/sec along a flight-path angle of  $-17^{\circ}$  and at a pitch angle of  $13.5^{\circ}$ , a roll angle of  $3.5^{\circ}$ , and a yaw angle of  $-11.5^{\circ}$ . The sink velocity of this airplane test was 6.64 m/sec, which is about twice the design sink velocity. The port landing gear contacted the impact surface 0.027 sec after initial ground contact, at which time the airplane had a pitch angle of  $14.25^{\circ}$ . At 0.037 sec into the impact, the nose gear contacted the impact surface, resulting in total collapse of the gear at 0.10 sec, while the airplane remained at a constant  $13.25^{\circ}$  pitch-up angle. The main landing gear reached its greatest deflection at 0.118 sec with the fuselage undersurface parallel with the impact surface. The spring steel landing gear started to spring back, imparting a forward (nose-down) pitching moment to the airplane which resulted in a  $-28.75^{\circ}$  pitch attitude of the airplane with the collapsed nose gear in ground contact. The airplane then settled back onto its main landing gear as the airplane pitched up, deflecting the main gear and once again imparting a spring back that lifted the airplane off the impact surface in a nearly level attitude. It then settled onto the main gear and collapsed nose gear and rolled to a stop about 80 m from touch down. The pilot and copilot dummies remained relatively motionless during the impact.

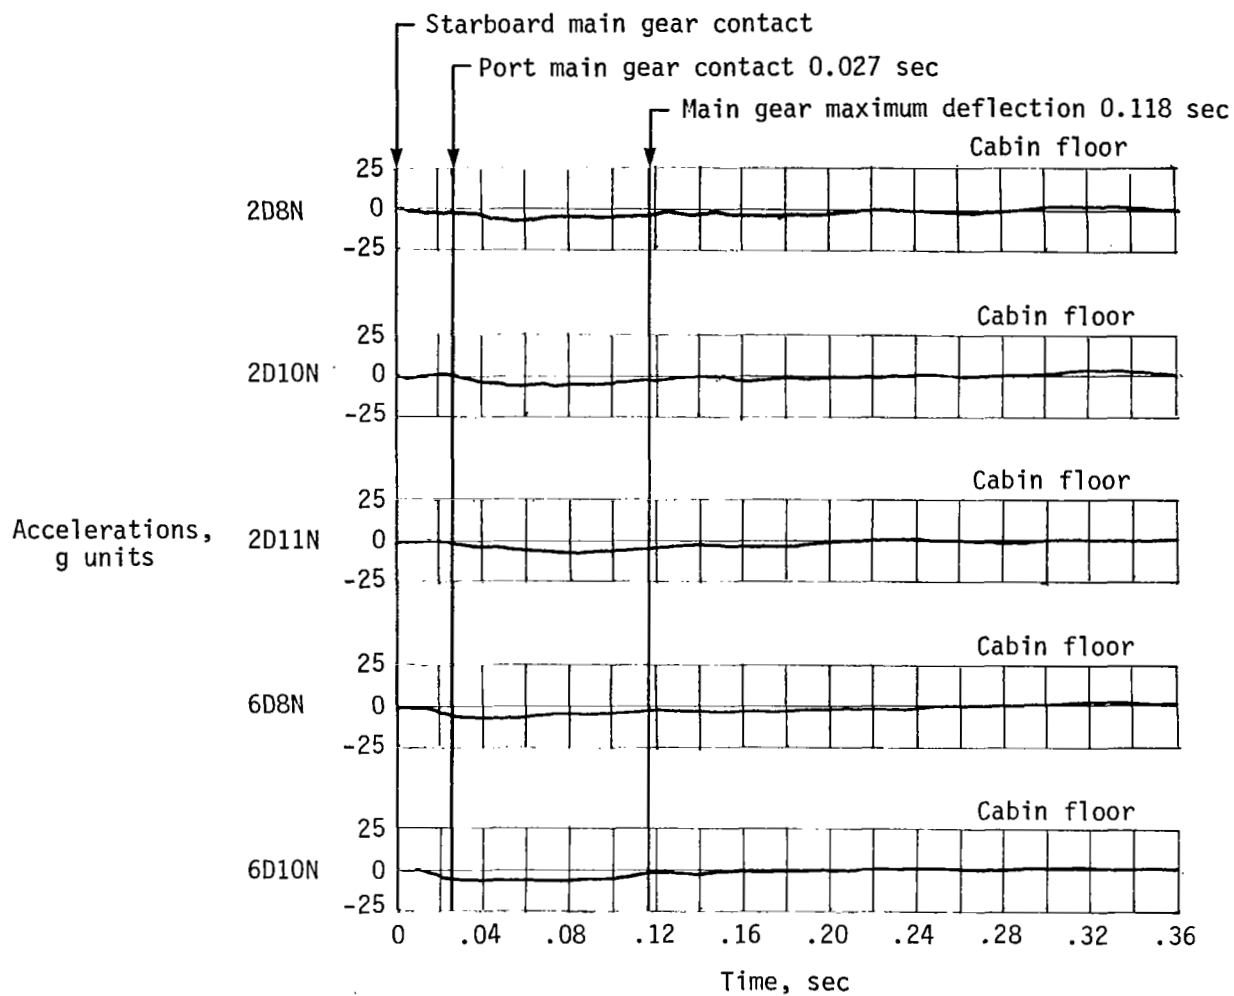
(a) Normal accelerations of cabin floor.

The acceleration histories on the cabin floor and in the dummies as well as the loads in the restraint systems are presented in figure 16. The acceleration histories show that the main impulse lasted for about 0.12 sec as the main gear deflected to its fullest. The peak value of the normal acceleration on the cabin floor is about -5g, while the peak longitudinal accelerations are only about -2g. There was very little acceleration response due to the main gear spring back. The accelerations in the dummies' pelvic regions and heads (fig. 16(c)) were about  $\pm 10g$  maximum in both the normal and longitudinal directions. The loads experienced by the restraint harness system (fig. 16(d)) were extremely small, with the greatest level (600 N) occurring in the copilot's shoulder harness.

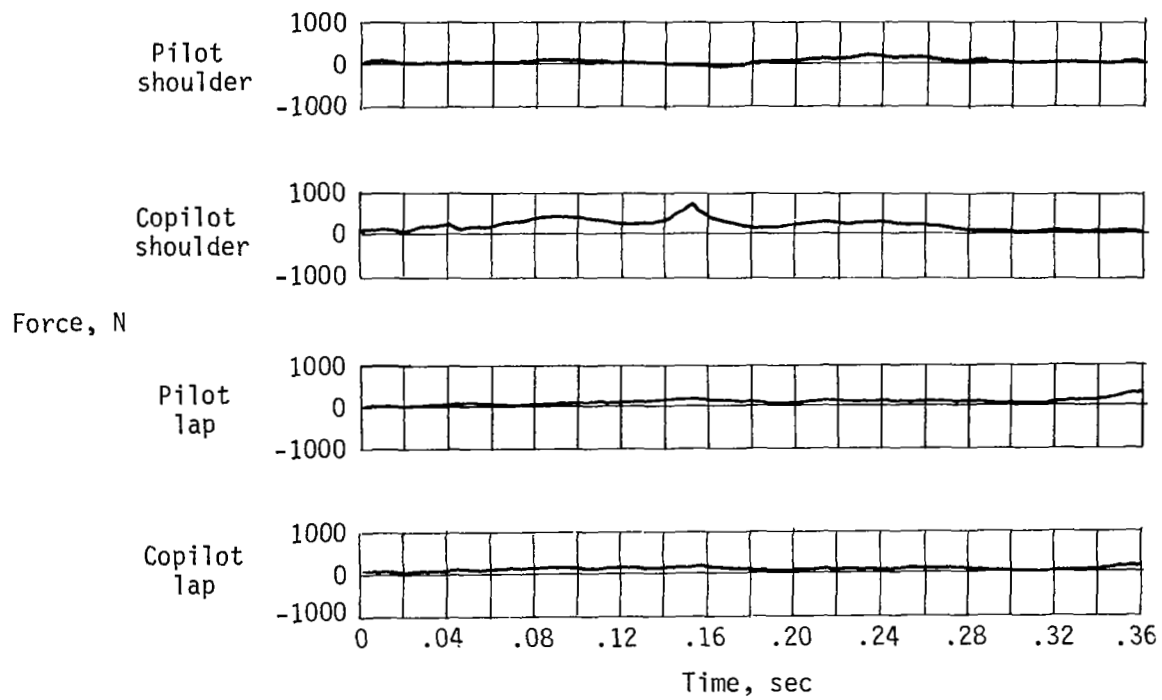
(d) Loads in restraint harness system.

The loads experienced by the restraint systems in the hard-landing specimen were only about 600 N. The shoulder harness and lap belts in the roll-impact and nose-down-on-soil specimens experienced average loads of about 3400 N and 2600 N, respectively. The nose-down specimen experienced loads in the opposite order of the other specimens, about 2000 N on the shoulder and about 3900 N in the lap belt. The absence of impact between the dummy and structure in the nose-down specimen probably caused this difference.

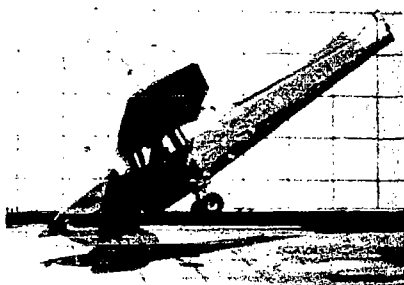
Figure 20.- Crash sequence photographs of nose-down test.

A photographic sequence (fig. 20) illustrates the crash dynamics of the airplane test specimen during a negative-pitch (nose-down) crash starting at initial ground contact. The airplane contacted the concrete impact surface on the nose landing gear with a velocity of 24.7 m/sec along a flight path of  $-32^\circ$ , a pitch angle of  $-30^\circ$ , a roll angle of  $7.5^\circ$ , and a yaw angle of  $0.7^\circ$ . The fuselage nose contacted the impact surface 0.048 sec after initial ground contact.

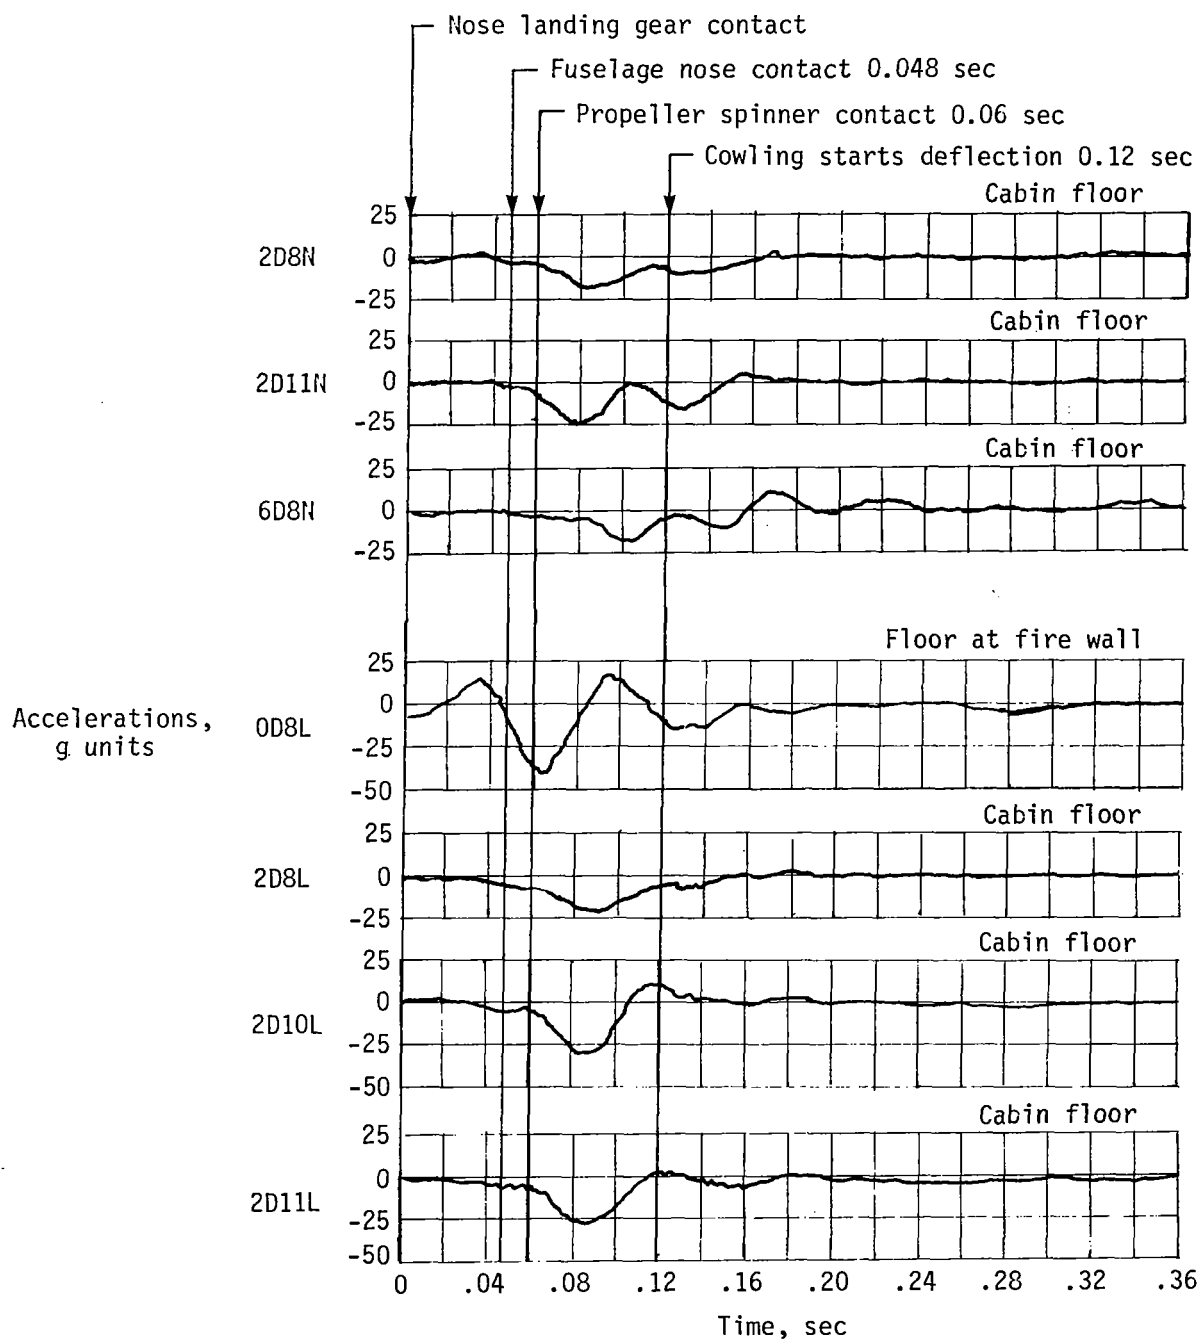
(a) Acceleration on cabin floor and fire wall at floor.

Time histories of the accelerations on the cabin floor and in the dummies and of the loads in the restraint systems are presented in figure 22. The normal accelerations (fig. 22(a)) on the floor were about  $-20g$  on the port side and  $-25g$  on the starboard side. The difference can be attributed to the  $7.5^{\circ}$  starboard roll angle at initial impact; this roll caused higher accelerations on the starboard side. The same results were experienced in the longitudinal accelerations, which were about equal to the normal accelerations in the same location. These airplane floor accelerations were low and resulted from the airplane structure absorbing much of the impact energy through structural crushing. The acceleration values of the fire wall at 0F7N and 0F7L were both  $-25g$ . The fire wall accelerations at 0D8L were higher, and the traces resembled a sine wave. The nose landing gear broke away close to this location. The accelerations on the structure started about the time the engine propeller spinner contacted the ground and lasted about 0.06 sec, or until the structure started to collapse.

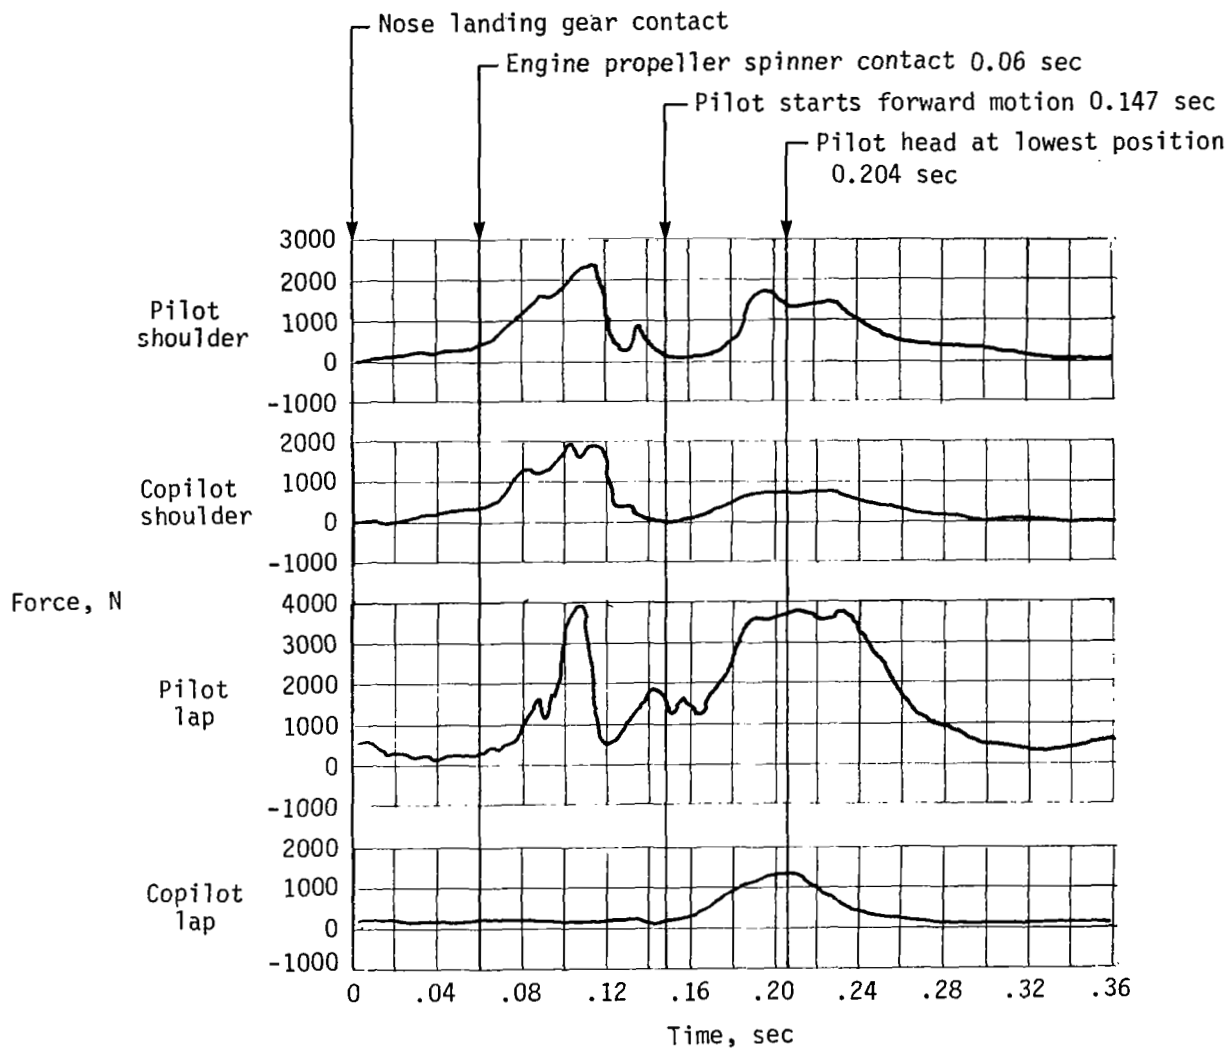
(d) Loads in restraint harness system.

The loads experienced by the restraint system are presented in figure 22(d). There were two loads applied to the harness system. The first load occurred during the initial crash impulse and the second at the time the dummies had pitched forward to the farthest position. The pilot's lap belt shows two equal peaks of about 3900 N. The reason the copilot's lap belt did not experience the first peak is unknown. The shoulder harness maximum loads were nearly the same for both dummies. However, the loads first peaked at about 2000 N; the second peaks occurred at about 1600 N for the pilot and about 800 N for the copilot.

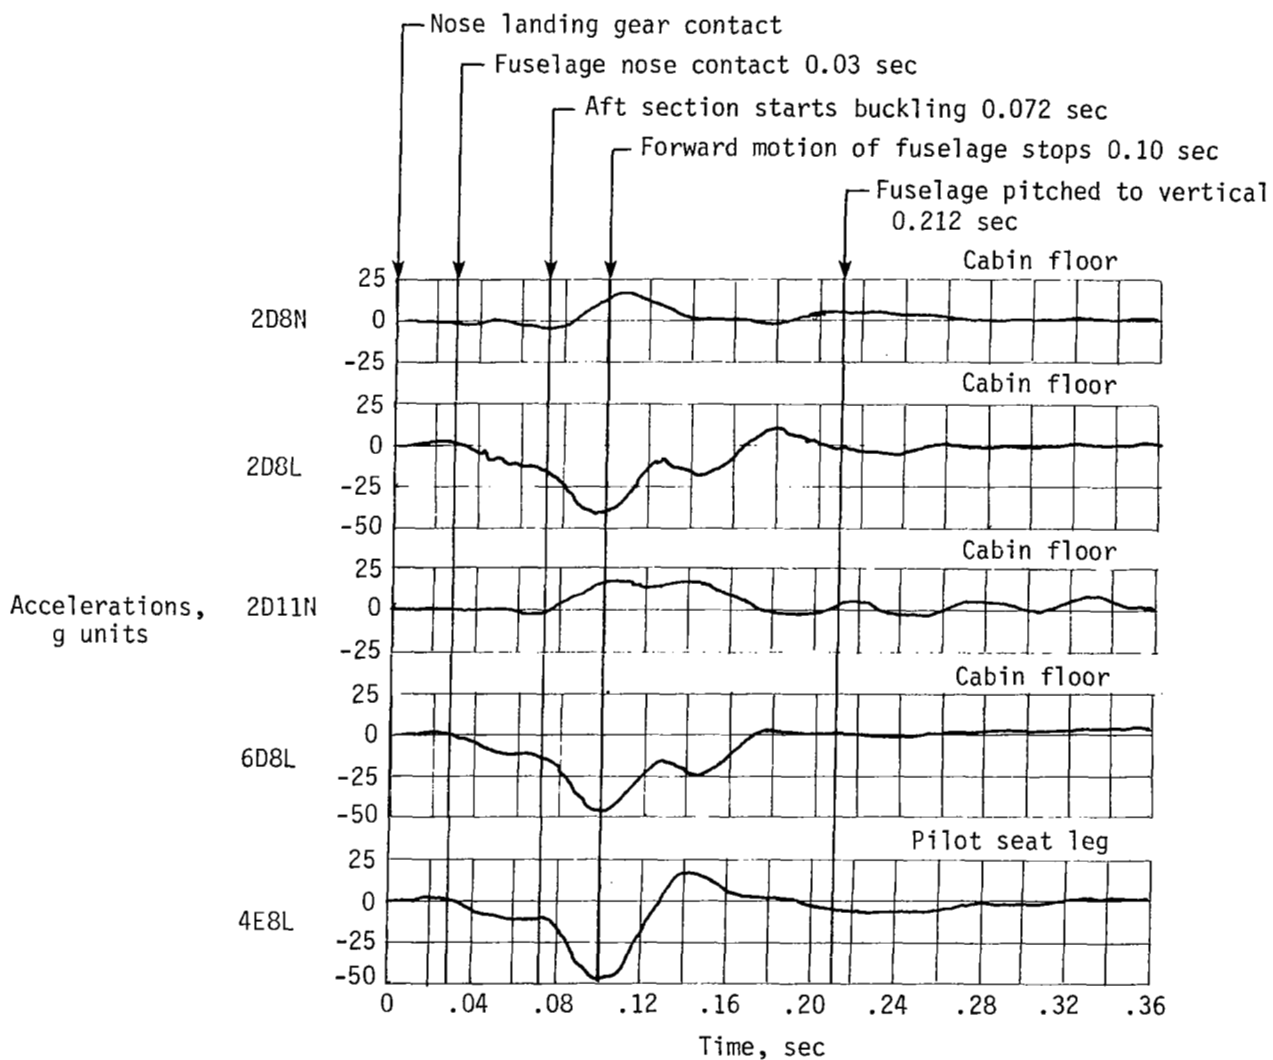
(a) Accelerations on cabin floor and pilot's seat leg.

Time histories of the accelerations on the cabin floor and in the dummies and of the loads in the restraint systems are presented in figure 25. The normal accelerations (fig. 25(a)) indicate a reversal of the expected load direction during the time that the fuselage cabin pitched up to a vertical position. There was little indication of the early part of the initial impact which ended at about 0.072 sec as a result of the massive crushing of the forward fuselage structure. Peak accelerations of about -45g longitudinally on the floor occurred at about 0.10 sec as all forward motion came to a stop. The fuselage had almost totally collapsed by this time.
